Report No. UT-03.01

**UTAH ROCKFALL
HAZARDS INVENTORY
Phase I**

**Utah Department of Transportation
Research Division**

April 2002

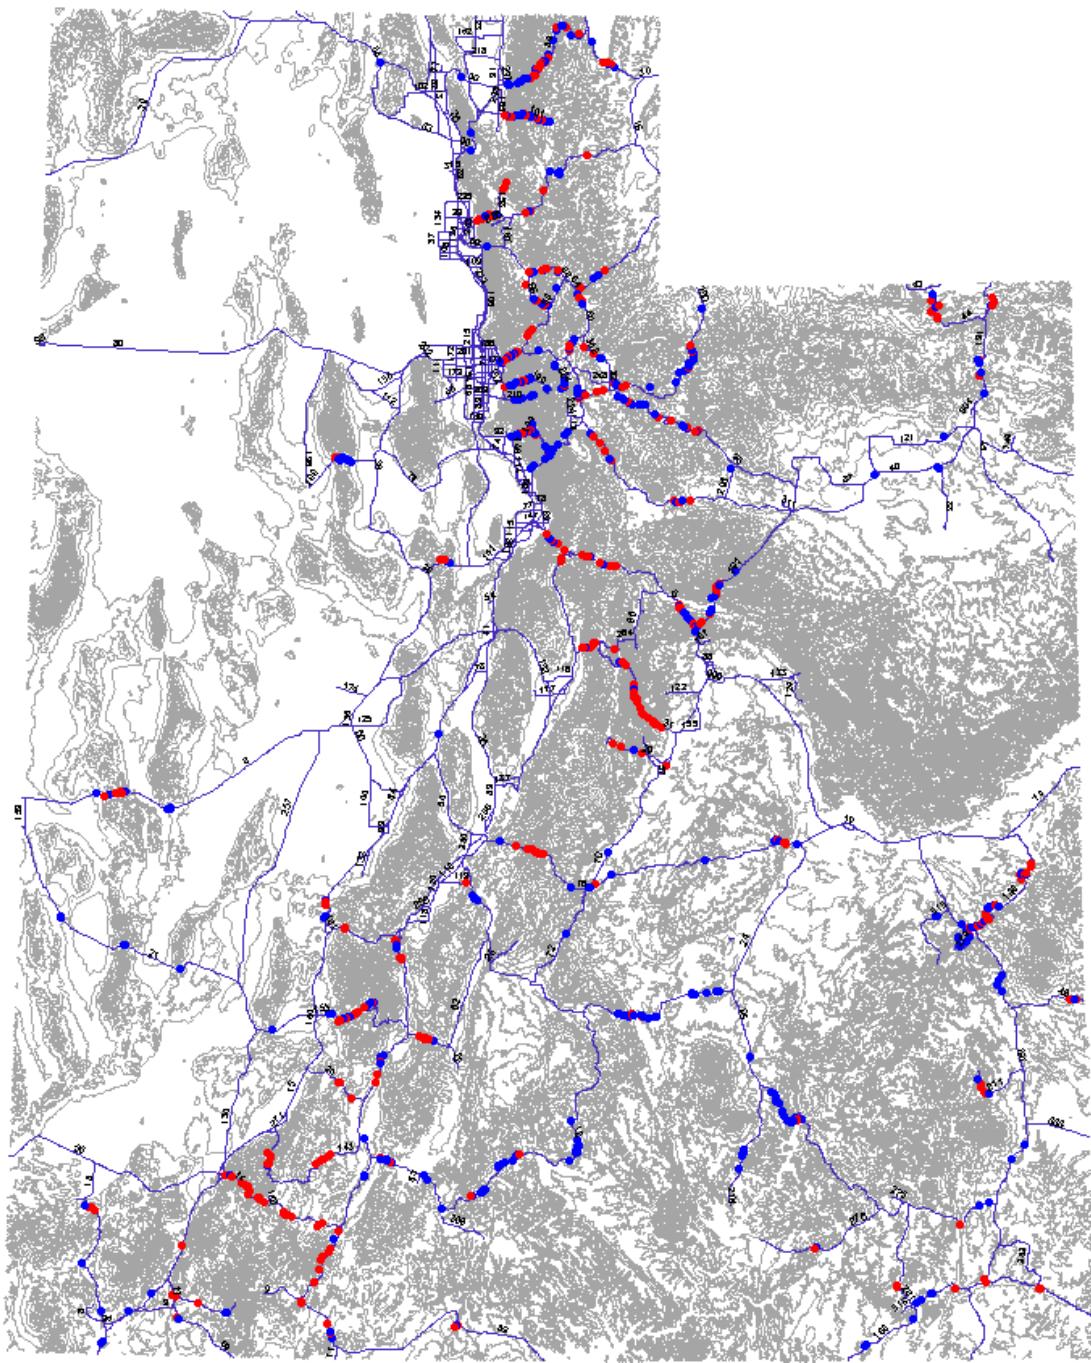
roadside slopes classified as A is 134.8, as B is 155.3, and as C is 7.5 for a total of 297.7 kilometers (185 miles). It should be noted that sites classified as C are a very small subsample of sites in this category as they are essentially excluded from the inventory. As stated in the Section on methodology, C-rated slopes are considered low-risk and would add un-needed clutter to the database. However, a few have been included in order to get a feel for their nature and how they are distinguished for the A-rated and B-rated sites. Figure 2 shows the distribution of problem rockfall sites throughout Utah.

Figure 2. Distribution of rockfall sites classified as A (dots shown in red) and B (dots shown in blue).

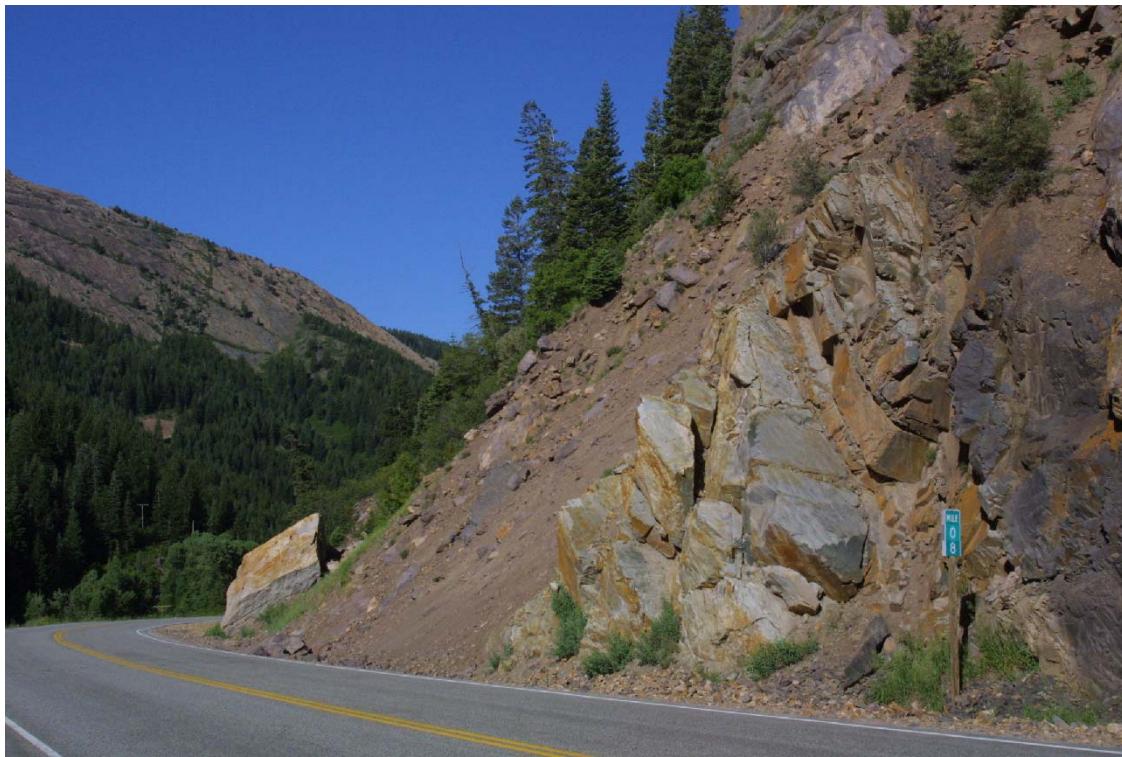
Figure 8. Photo IMG_1138 corresponding with the data point shown in Figure 7 can be automatically retrieved.
